FATAL ACCIDENTS.

FATAL ACCIDENTS  
-----

TINTERN BRIDGE AT 4 MILES 32 CHAINS

FATAL ACCIDENTS SUSTAINED BY  
ENGINEERING DEPARTMENT STAFF.  
-----

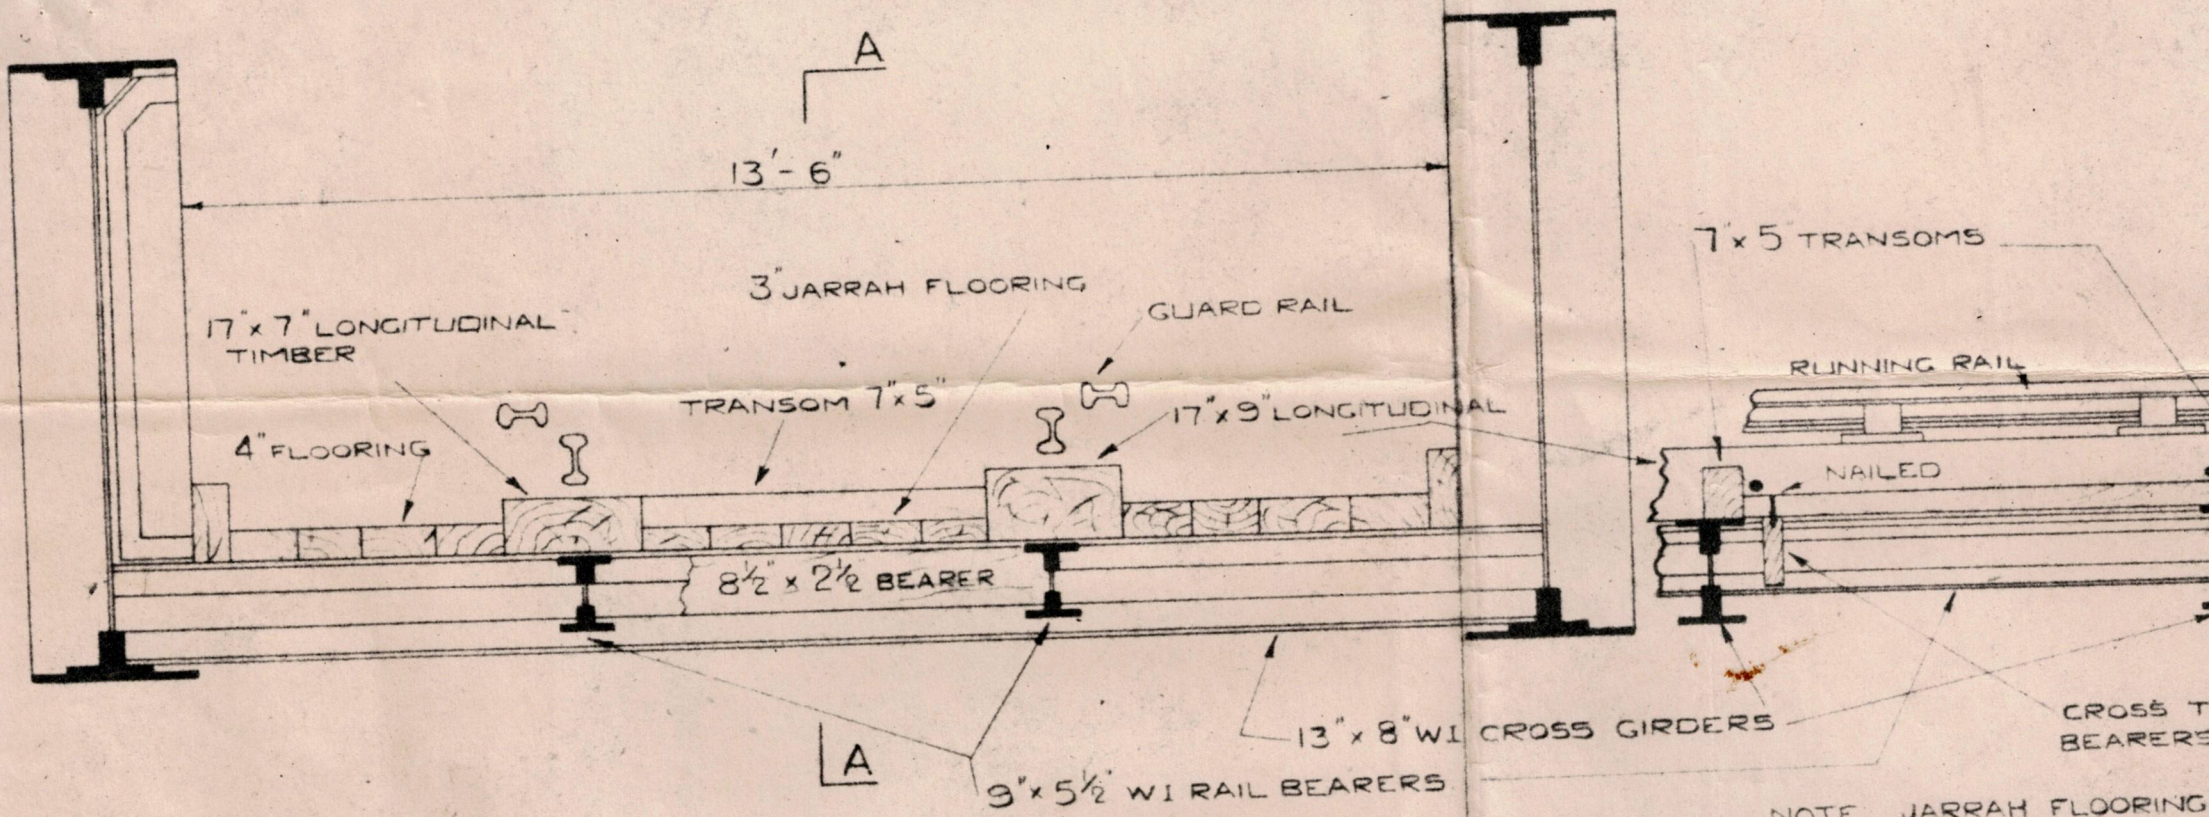
TYPICAL CROSS SECTION OF BRIDGE.

A Ganger and five men were working on a river bridge inserting packings under the longitudinal timbers. In order to ease up the longitudinal timbers for this purpose, keys were placed on the decking and bars were used, using the keys as a fulcrum. The decking in the four foot consisted of 3" Jarrah flooring, one end of which rested on a cross girder, and the other end on a 8 1/2" x 2 1/2" timber bearer between rail bearers. This is indicated on the attached sketch.

It is evident that the Ganger and lengthmen did not appreciate the load which they were applying to the decking by the means adopted to lift the longitudinal timbers, and the 8 1/2" x 2 1/2" cross timber failed under the load. Two men fell through with the displaced decking and received fatal injuries.

NOTE JARRAH FLOORING  
WAY SUPPORTED  
END ON CROSS  
BUT ON CROSS T  
THE OTHER

PART LONGITUDIN  
SECTION A.A.

I should be glad if you would arrange for all Gangers under your control to be made aware of the circumstances of this mishap.
