GLOPPA SAND & GRAVEL PIT.

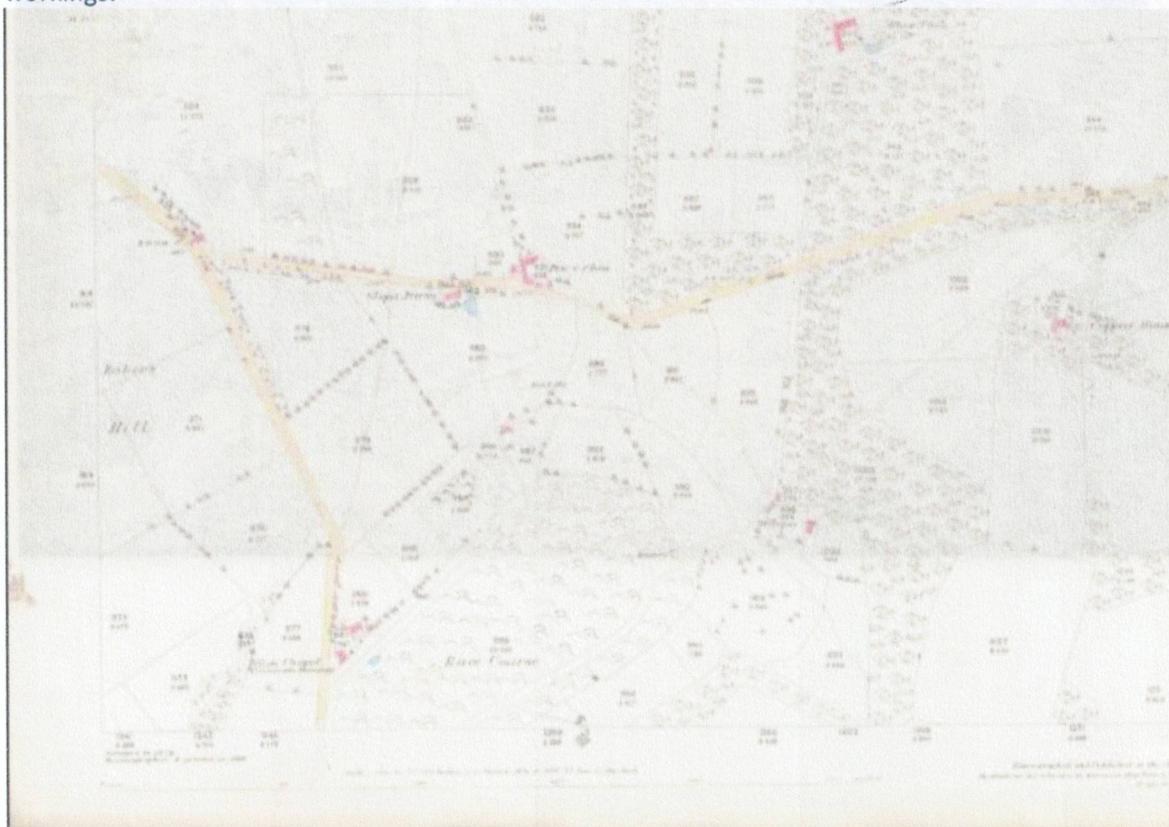
The first 25-inch OS map, published in 1874, shows a small “sand pit” in the area known as Gloppa (sometimes spelt Gloppe), just to the north of the Old Racecourse on the hill west of Oswestry (ref. 1). Note that it also shows a small “quarry” near the easternmost part of the racecourse; although it is not marked on the later maps, it was subsequently enlarged, and can still be seen as shallow workings:

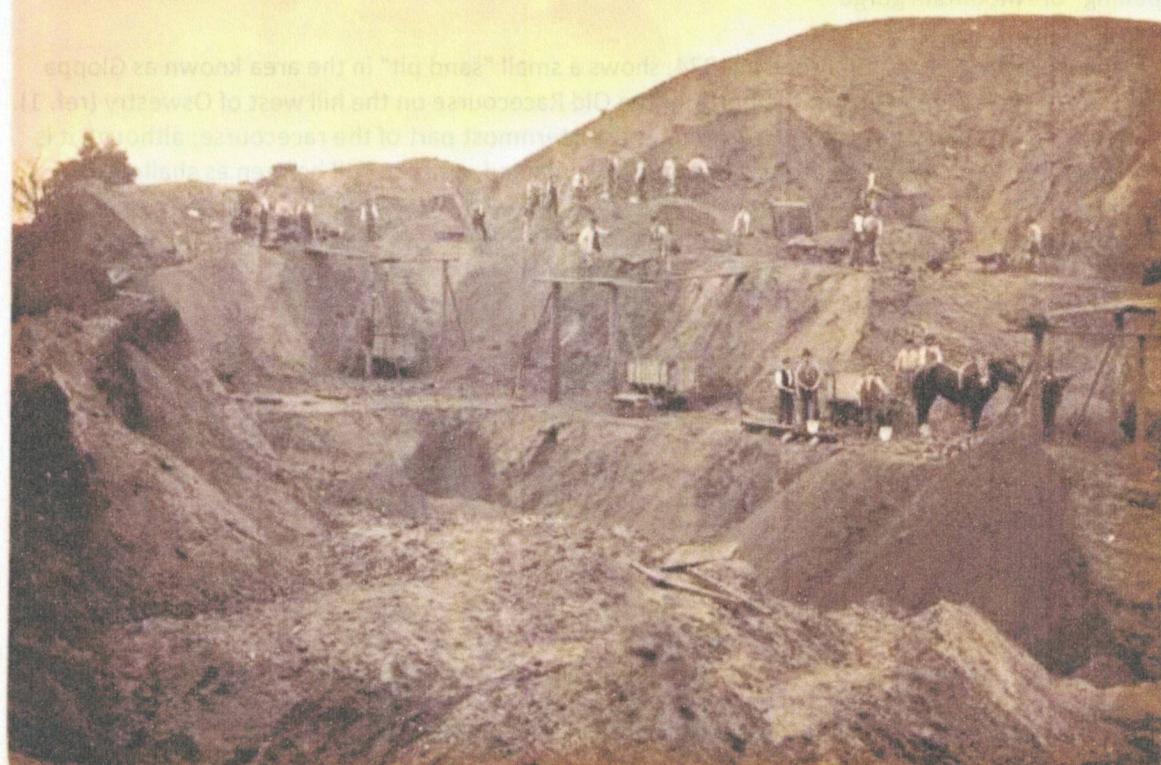
The first shows the working pit with three simple inside-framed drop-side timber wagons, a horse, and no less than 26 men. The track gauge is difficult to determine, but looks somewhere between 2 and 3 foot. It appears that the excavated material is being thrown against screens to separate out large stones, and the material which passes through the screens is wheelbarrowed onto some very flimsy and unsafe-looking gantries to be tipped from a great height into the wagons:

Some photos appear on the British Geological Survey website (ref.3), catalogued as "Gloppa, near Oswestry. Sand pit in drift", and stated as "taken 1/1/1892 by A.C. Nicholson of Oswestry for the BAAS report for 1892" but presumably they were actually taken a while earlier while sand extraction work for the waterworks was still in progress (copyright British Geological Survey, P2326 15 to 21).

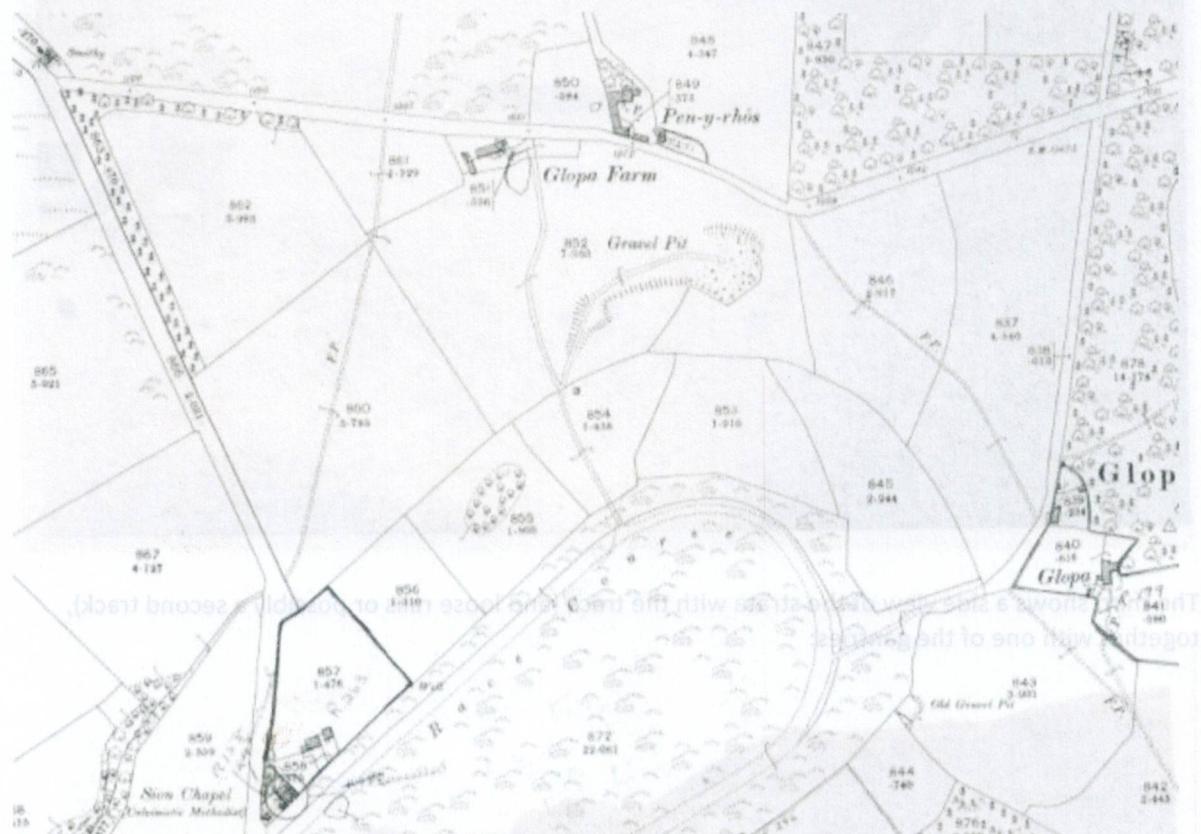
The second edition of the 25-inch OS map, published in 1901 (ref. 1), does not show the tramway seen in these photos, but the pit is shown as enlarged eastwards compared to the earlier map, and is marked "gravel pit" (not sand pit). The pit had been described in 1892 as "not being worked", so it appears that the horse tramway had been removed on completion of the first phase of the waterworks construction:

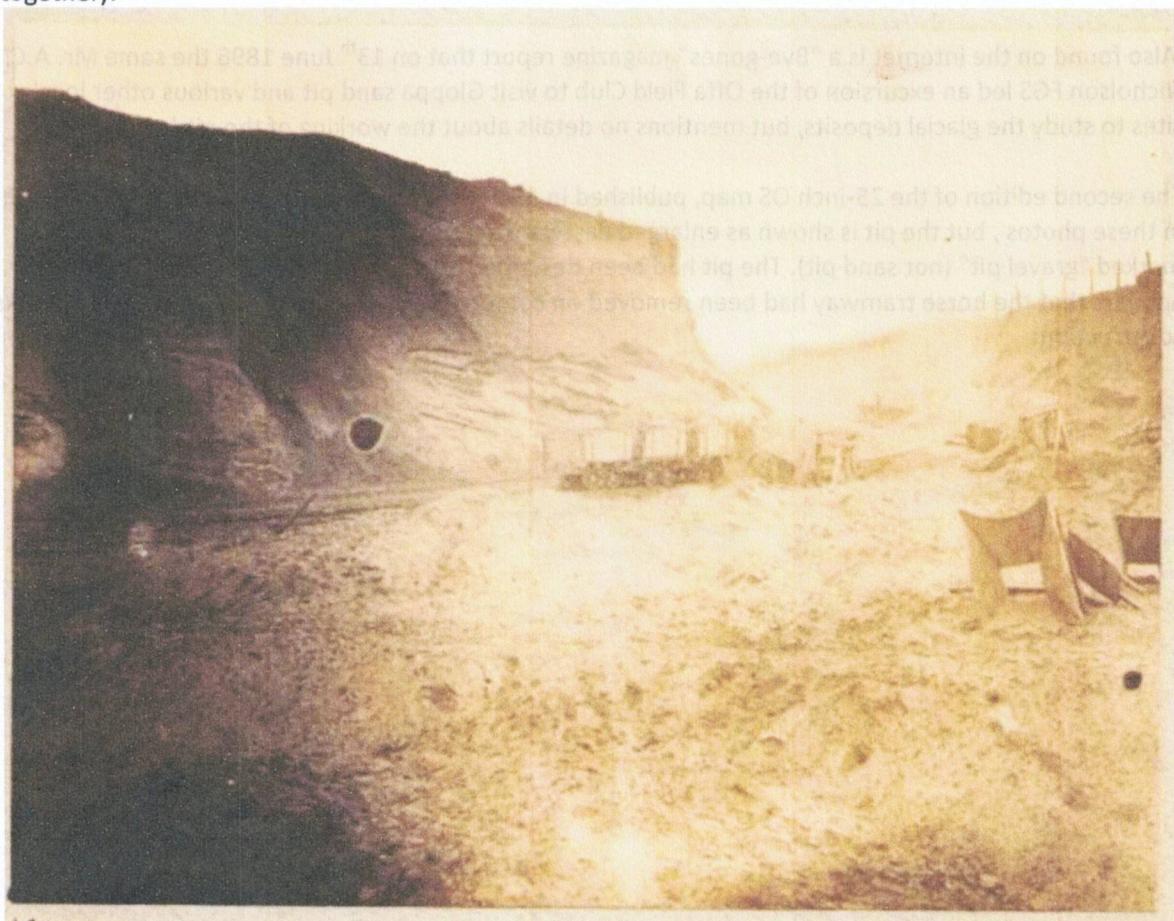
The second shows a narrow-gauge track with three similar wagons (or perhaps the same ones coupled together):

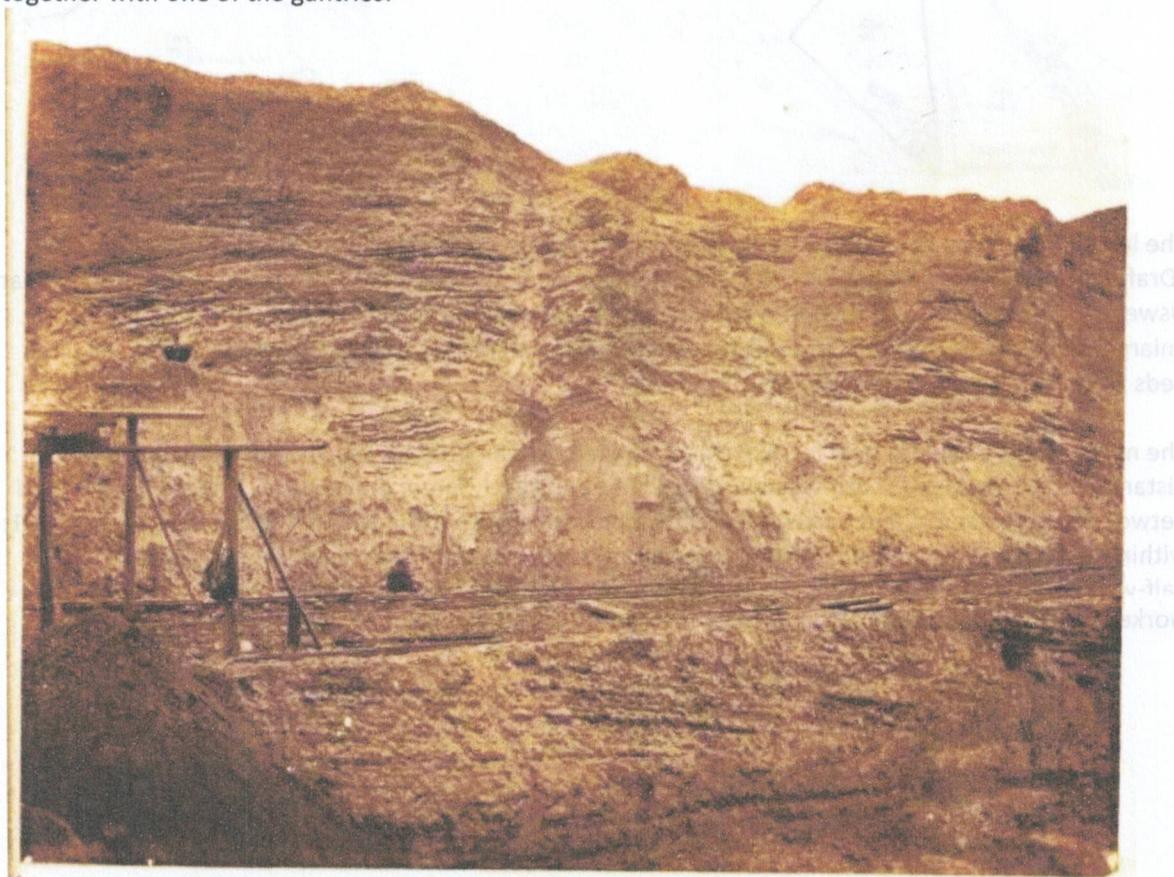
The third shows a side view of the strata with the track (and loose rails or possibly a second track), together with one of the gantries:

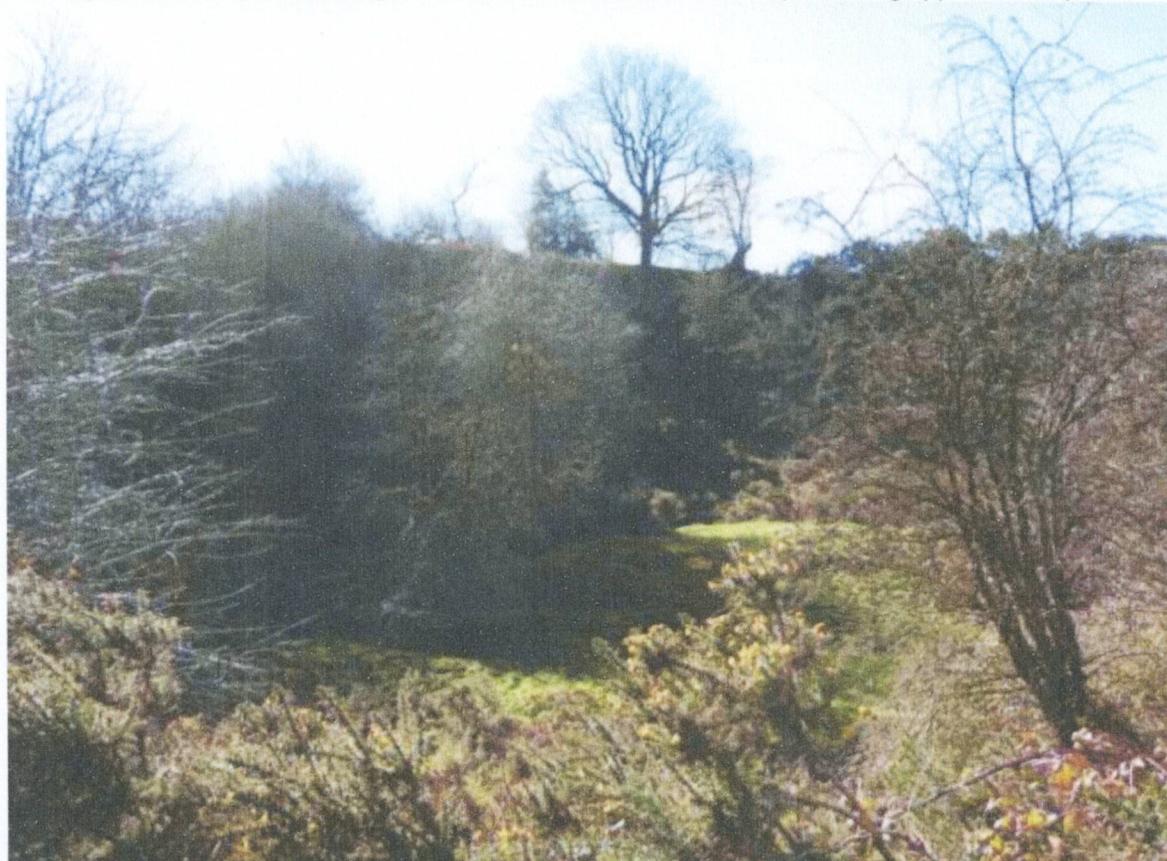
In February 2025 I explored the sand/gravel pit and the tramway trackbed with friends Tom Lerwill and Chris James, by kind permission of the local farmer (there is no public access). The pit itself is about 20m deep with sides sloping at around 45 degrees, and the material is sandy soil with rounded pebbles of various types of rock. It is quite overgrown with gorse, brambles, shrubs and trees, and it is difficult to make much sense of the hummocky surface which was left in the base of the pit when working ceased many decades ago. This view is from the rim of the pit looking approximately south:

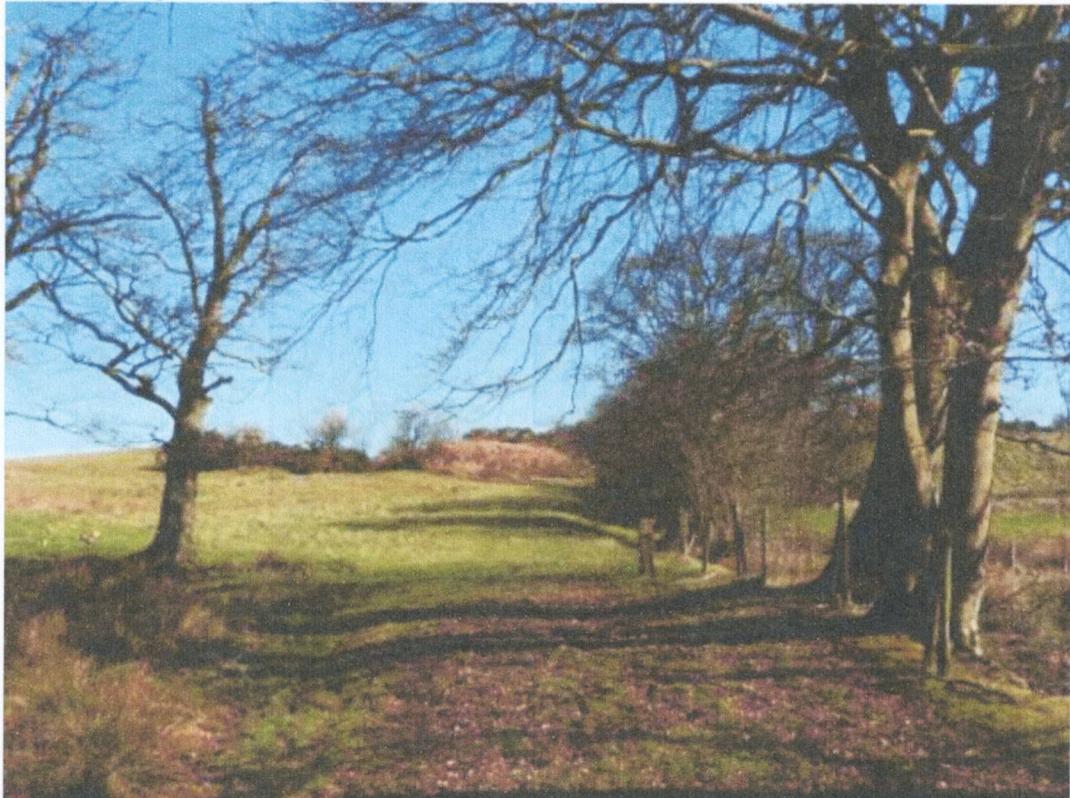
The cutting is seen in the background of this view, and the pit is behind the bracken-covered mound. Somewhere just behind the tree on the left is the site of the little shed shown in the 1926 map, but there is no sign of it on the ground:

We couldn't discern where the tramway was laid within the pit, but it would have followed the cutting coming out of it in a south-westerly direction, of diminishing depth as the original ground level falls away. The trackbed seems to be level or downhill in the direction of loaded wagons.

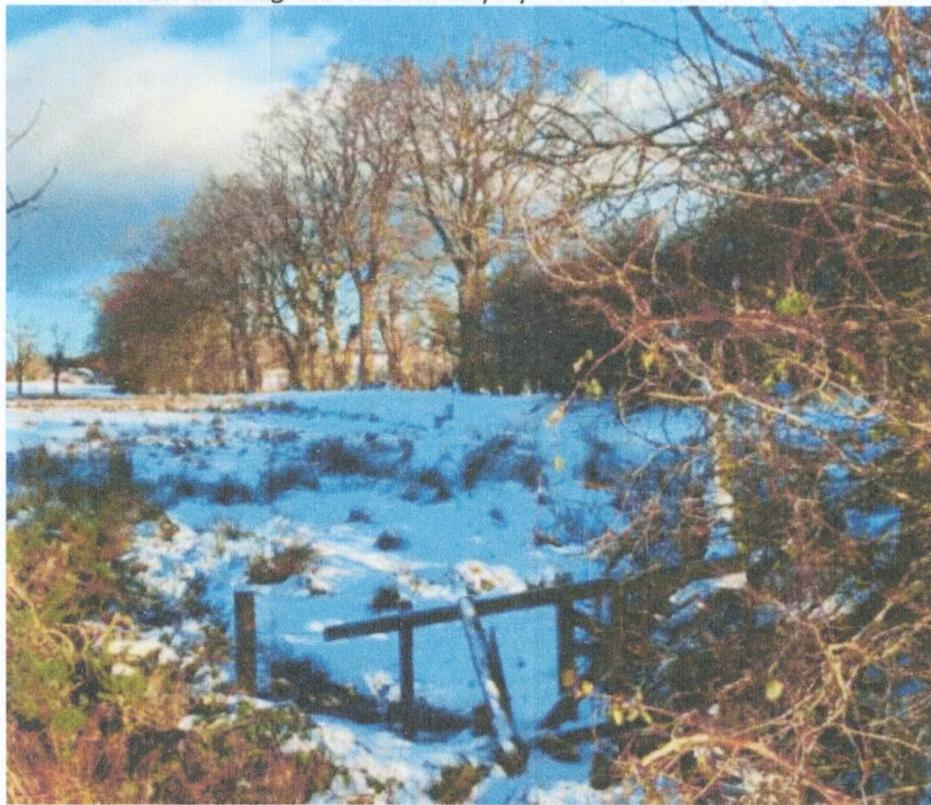
A view taken from the road during the snow of January 2025 clearly shows the height of the embankment increasing as it nears the lay-by:

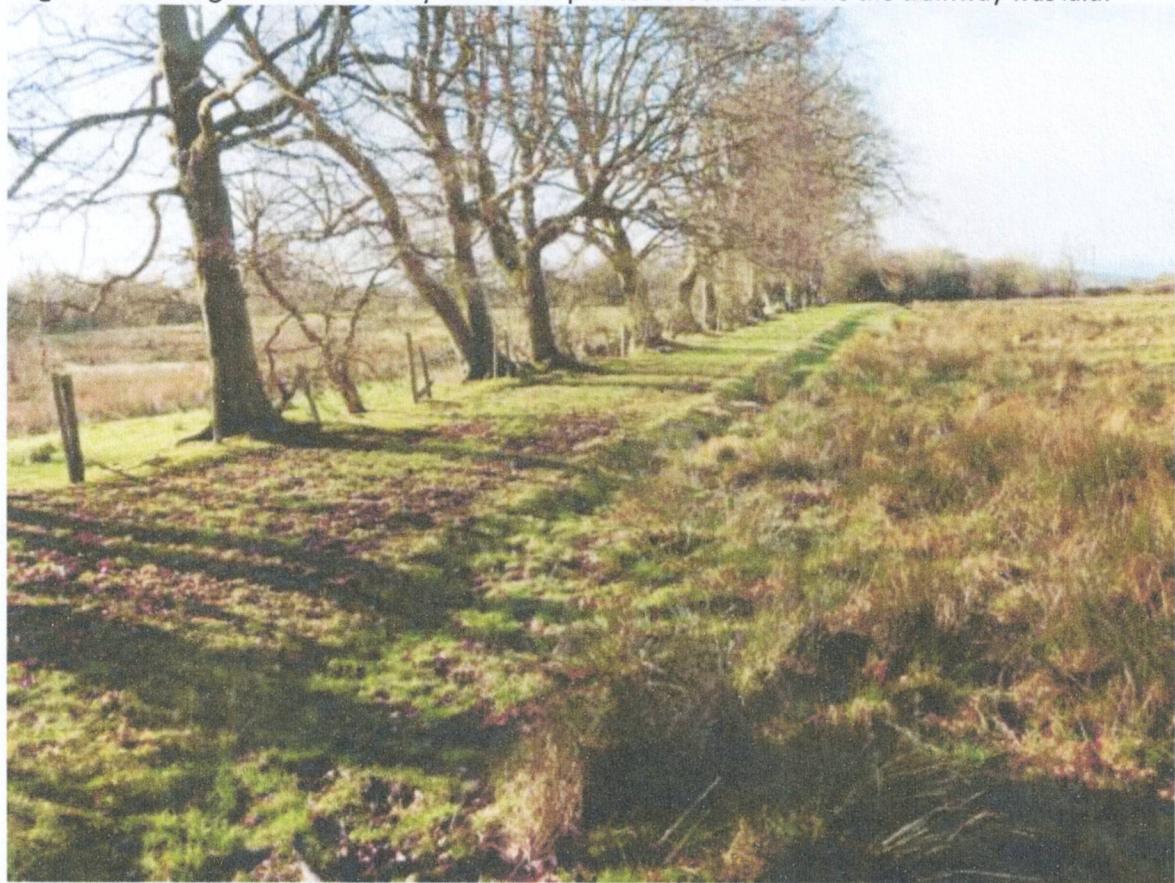
Looking towards the road from the same spot, the tramway embankment can be clearly seen. The elegant row of large beech trees may have been planted around the time the tramway was laid:

As it approaches the road, the embankment broadens for the run-round loop, and ends in a dense hedge (seen in the background of the photo above).

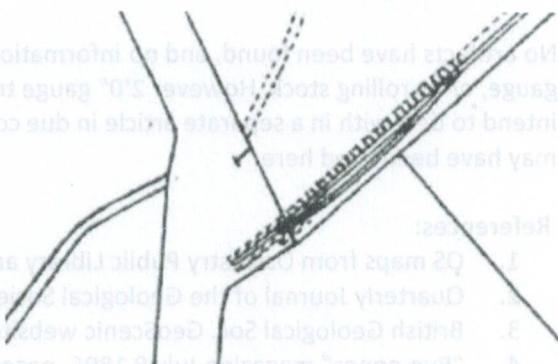
This detail of the 1926 map shows that the tramway continued into the lay-by, with cross-hatching perhaps indicating a timber structure so that wagons could be tipped directly into Lorries. However no signs of this remain on the ground, and the whole area has been cleared:

The next edition of the OS map in 1926 (ref. 1) is the one which shows the "tramway" running a distance of approx 400m south-westwards from a significantly larger gravel pit to a lay-by on the road between the racecourse and Carreg-y-big. It therefore seems that the whole line was relaid after 1901; within the pit there was a balloon loop, just before the lay-by there was a run-round loop, and about half-way there was a siding to a small shed. None of these features would seem necessary for a horse-worked line - but no information has been discovered about any locos at the site.
